モンゴル・ウランバートル市営バス
排ガス削減プロジェクト（実証事業）開始しました！

2019年10月30日～

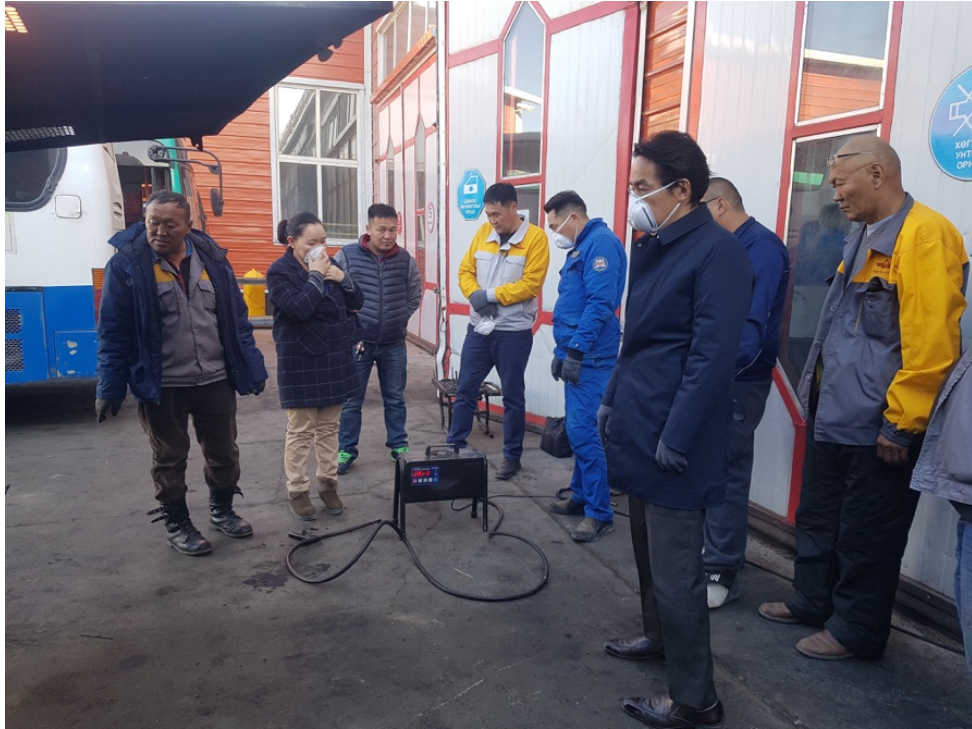
黒煙テストの様子（右から3人目・手前が弊社代表）

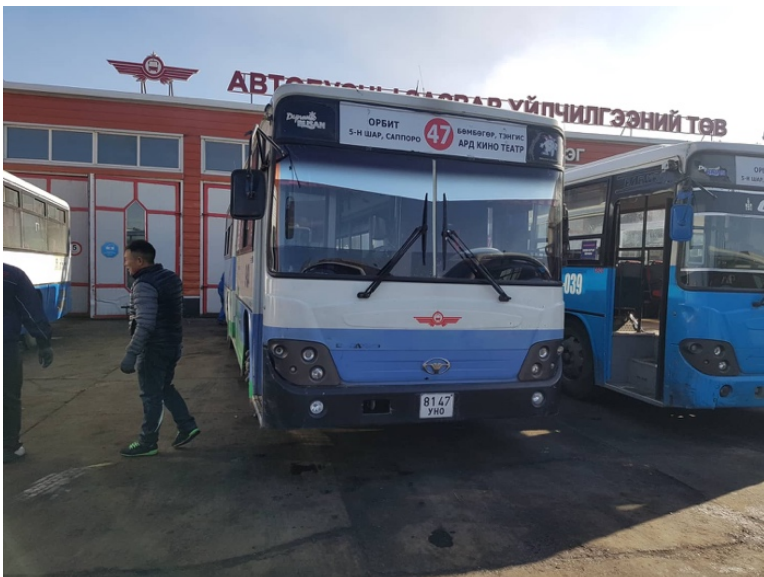
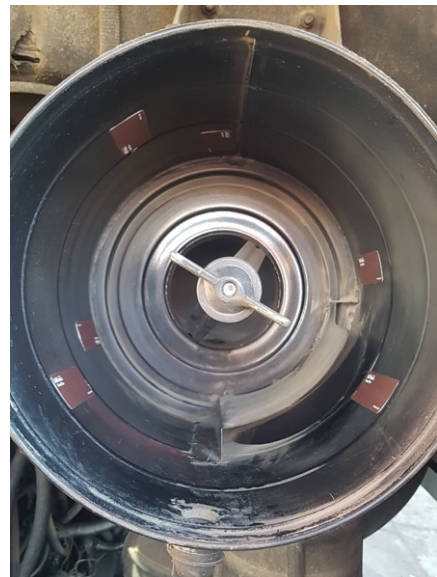
車両と取付写真

取付前 6.15 (m-1) → 取付後 3.29 (黒煙-46.5%)
